Upcycling,  
reinstating,  
forward thinking.

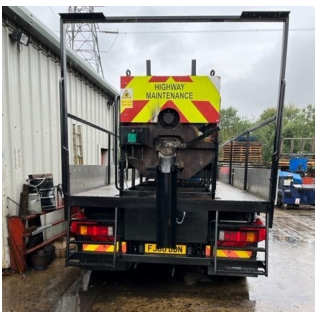
A new chute c/w an extension chute was fitted \*see reference image below\*.
